# LRS Uses in a Municipality

## City of Edmonton's Spatial Land Inventory Management (SLIM)

GIS-T

March 17, 2003

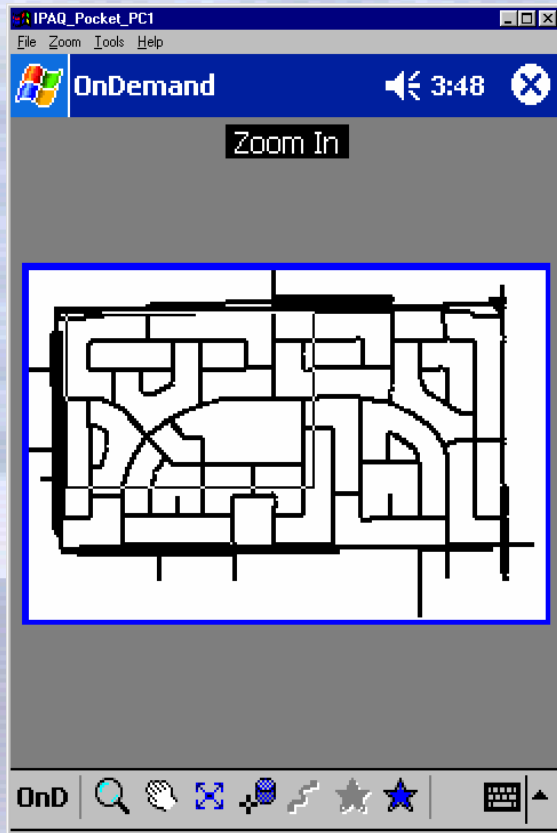
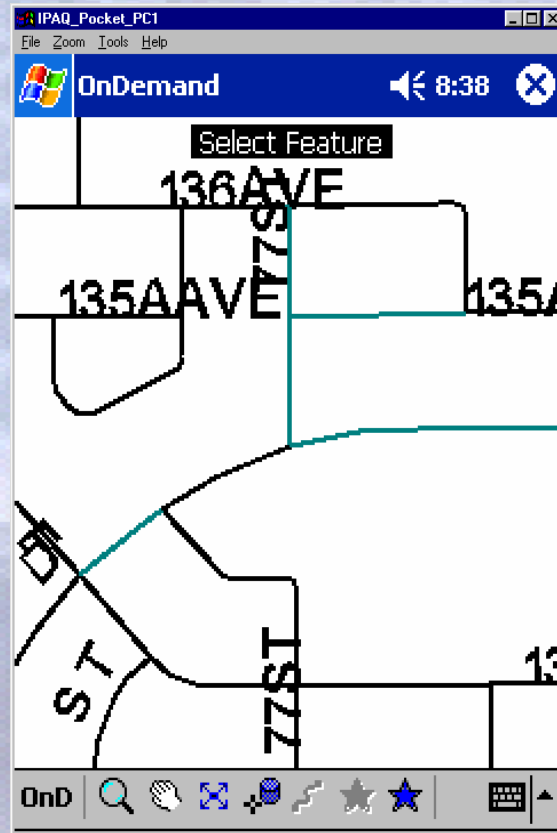
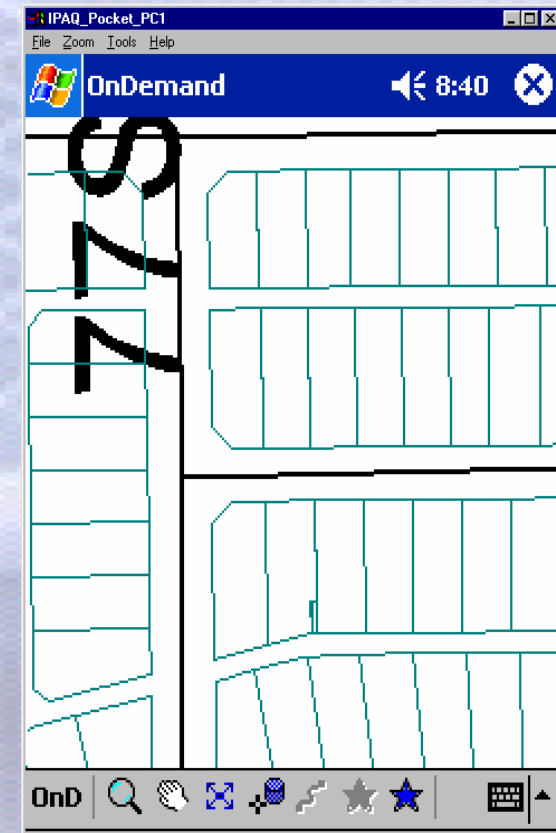
# PDA Data Capture

## Select details to display
